A study on environmental corrosion of gilded heritage structures of Royal Palace Patan, Nepal

This article presents the results of corrosion study carried out on 17th century gilded sample procured from the metallic golden window of Patan Royal Palace, Nepal. The characterization techniques employed in the study provide the detailed information about the environmental pollutants responsible for the corrosion and degradation of gilded window. The analytical results have revealed that the window has been made of pure copper sheet on which traditional mercury-amalgam gilding technique has been used. Particulate matters like elemental carbon, sulphur dioxide, chlorine and organic matter have been found to be the main factors responsible for the corrosion and degradation of gilded surface. The information obtained from the present study is expected to be the source of understanding and solution for the protection and conservation of the gilded heritage of Nepal.

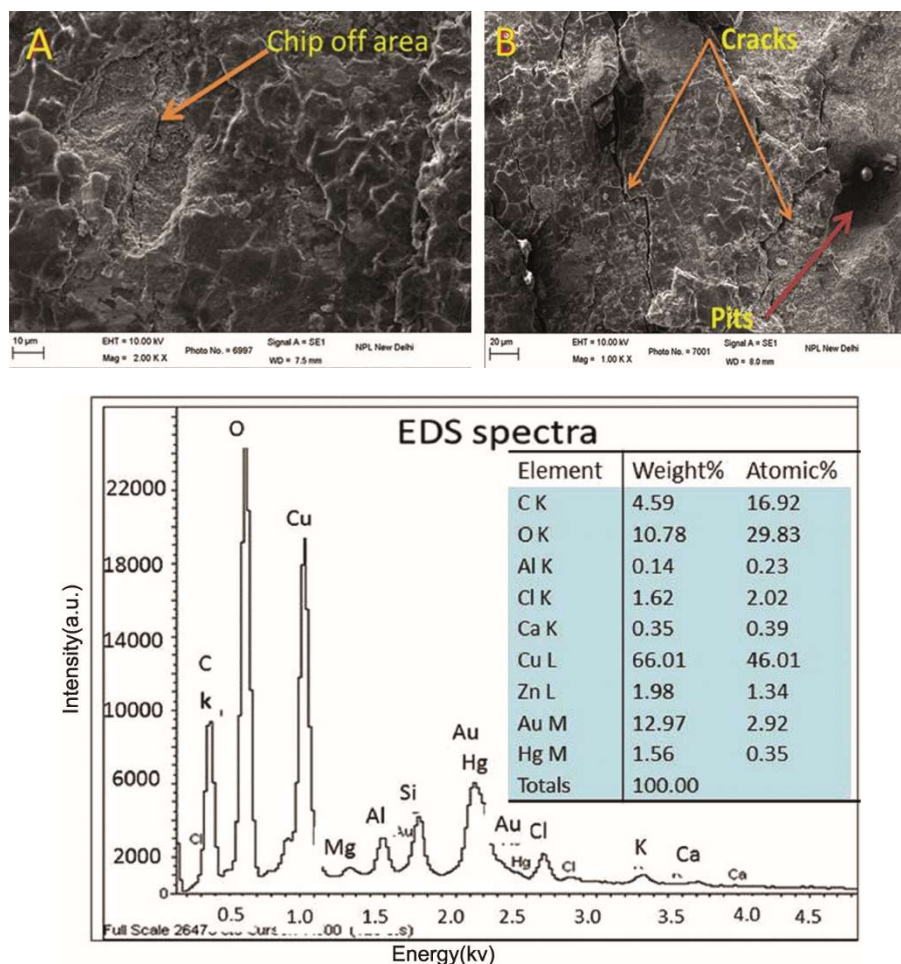
Prior to SEM imaging the same sample was cleaned in the acetone followed by the ultra-sonication to remove the environmental contaminants on the sample's surface. Images A and B shown in Fig. 6, represent the SE mode SEM micrographs of the cleaned gilded sample. SEM image marked as A shows the chipped off areas at certain places in the sample which may be due to the exposure to different atmospheric conditions during time. SEM image

marked as B revealed the presence of micro and nanocracks along with the evidence of pits at some places which are clearly indicated in the image. These pits may have been created due to the reaction of chloride or sulphate ions present in the environment as pollutant after forming the acids. The figure also shows the elemental compositional details of the corresponding areas of the sample.

Presence of various elements is depicted in the table shown as an inset of EDS pattern and also marked on the spectra peaks corresponding to different energies. Presence of elements like C, O, Si, Cl, Ca may be due to contaminants present in the atmosphere and the elements such as Mg, Al, K are expected due to the impurities in the copper sheet used for the gilding process. However, the presence of Au and trace amount of Hg proves that mercury-amalgam process was used in the making of golden window. This is further to be noticed here that the high amount of C in the EDS spectra still persists even after

Fig. 6 — SEM images (A and B) of the chip off area and the EDS spectra of the corresponding area of the cleaned sample.

cleaning the sample with the acetone followed by the ultrasonication.

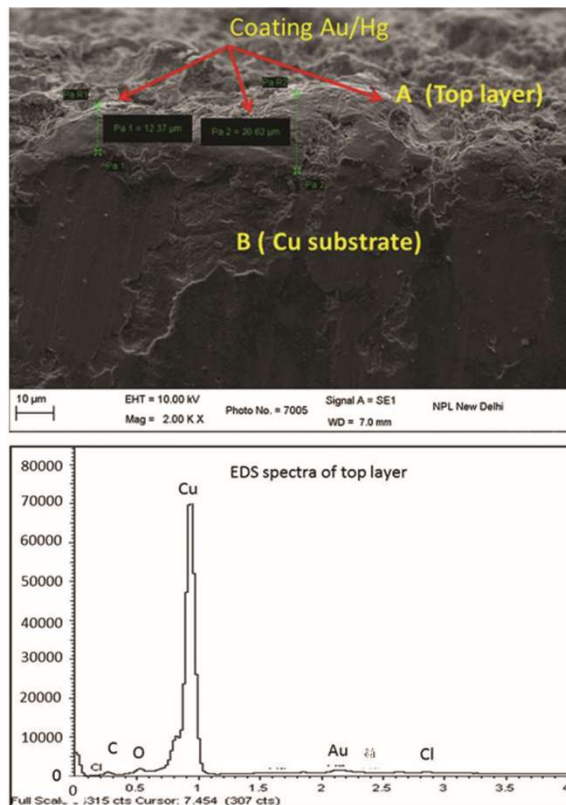
Fig. 7 — SEM image of cross sectional view and the EDS spectra of same area.
