## Small delamination detection in carbon fibre reinforced polymer composite beam by NDT and vibration analysis

Smaranika Nayak, Swetansu Pattnaik, Isham Panigrahi\*, Rameshkumar Nayak & Sambitkumar Parida  
School of Mechanical Engineering, KIIT University, Bhubaneswar 751024, India

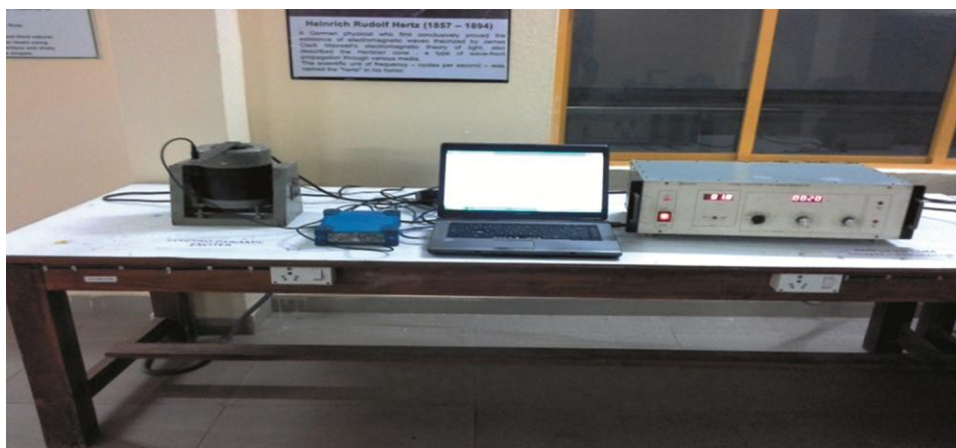
Fig. 1 — Setup for vibration test for carbon fibre beams.

cables, FFT analyzer (OROS-34) and a laptop loaded with NV GATE noise and vibration analysis software. For free vibration test, the beam is clamped at one end, keeping a length of 275mm free and an accelerometer is mounted at the other end of the beam. The FFT analyzer collects the vibration data and shows it in the FFT plots in laptop display. In this test, the cantilever beam is given an initial displacement of 20mm vertically and released such that it vibrated freely and allowed to damped on its own. The corresponding vibration data is recorded in the laptop. Three sets of readings are taken, each using beam with delamination and beam without delamination. Further harmonic excitation test was conducted with the help of electro dynamic exciter to compare vibration spectrum of beam with delamination and beam without delamination as shown in Fig. 1.

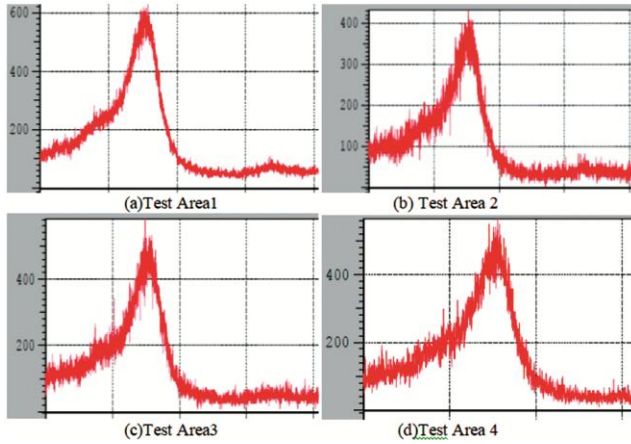
Fig. 4 — X-Ray diffraction crystalline intensity graph.

In the X-Ray diffraction analysis, it is found that the carbon fibre composite beam has lesser crystalline intensity in the areas where delamination is present. The following graphs as shown in figure-4 (a), (b), (c) and (d) represent the extent of crystal packing intensity within the structure. It can be inferred from XRD result of the areas -2 of beam in Fig. 4(b) where delamination is present; shows lesser presence of crystals which may be due to the presence of voids.

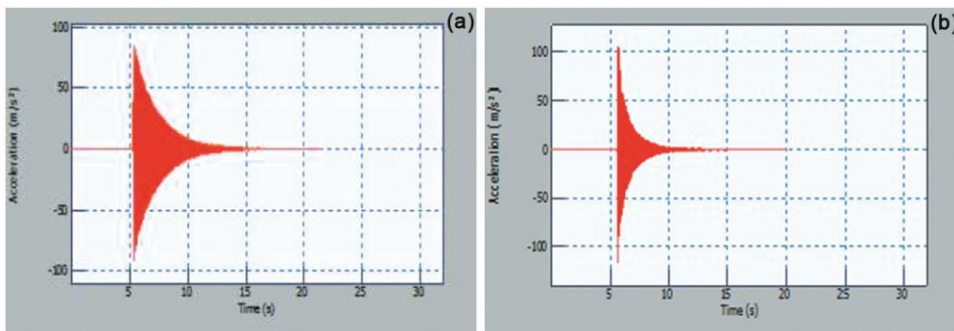
Fig. 6 — Time versus acceleration graph for carbon fibre composite without delamination (a) and with delamination (b).

The experimental result from the free vibration test with an OROS four channel FFT analyzer is performed and the test results are shown in Fig. 6. It can be clearly seen the rate of damping varies on presence of delamination in Fig. 6(b).
